COLLECTIVE SITE(S) IN FRONTLINE OBLASTS: ACCESSIBILITY ASSESSMENT

Dormitory of the State University of Biotechnology, Dokuchaevske village, Kharkiv district

OCTOBER 2025

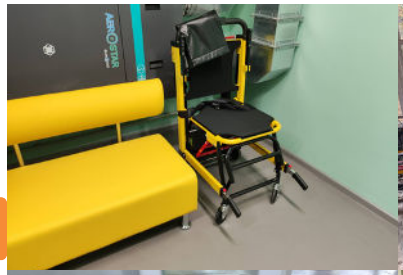
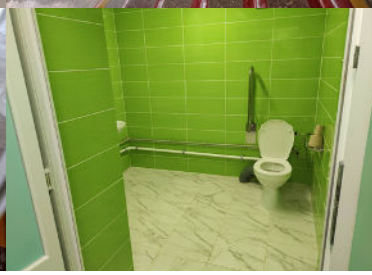
The building is in good structural condition, with no visible damage to walls, roof, or foundation. Constructed in the 1940s, the facility features thick brick walls and a slate roof with a stable wooden frame. No urgent repairs are required before further works begin.
The shelter in the basement is fully insulated and large enough for 150 people (no information on how many of these identify as having a disability). It is equipped with ventilation, alternative power, and water supply. Fire safety systems (detectors, extinguishers, alarms) are functional and properly installed.

- Accessibility Improvements Needed: Enhance external mobility access with ramps, anti-slip surfaces, and accessible doors.
- Facilities Upgrades: Improve shower accessibility and provide inclusive furniture.
- Overall Assessment: The facility demonstrates high readiness for continued long-term use as a collective site, requiring only targeted accessibility upgrades.

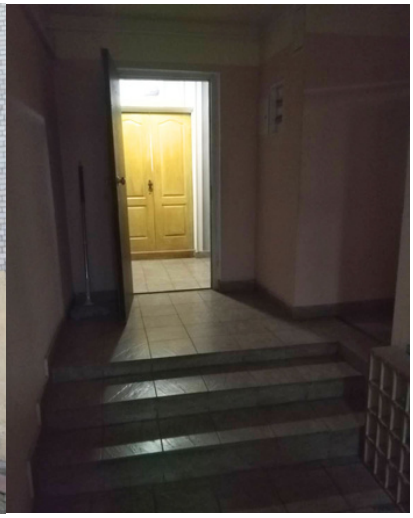
- Accessibility Gaps: The building lacks adequate features for people with disabilities or limited mobility.
- Limited Access: Ramps are available only at the entrance; internal doors and corridors are not adapted.
- Vertical Mobility: The elevator is non-functional, restricting access to upper floors.
- Provide emergency lighting, alarms, and first-aid kits throughout the premises.
- Repair and service the elevator to ensure mobility for residents with disabilities and older people.

- Install internal ramps and non-slip flooring to enable safe movement throughout the building.
- Adapt WASH facilities with grab bars, raised toilets, and sufficient maneuvering space for wheelchair users.
- Ensure access to a functional and insulated shelter within or near the building.
- Add tactile paving and clear signage (including Braille) for people with visual impairments.
- Provide accessible entrances, benches with armrests, and parking spaces for persons with reduced mobility.

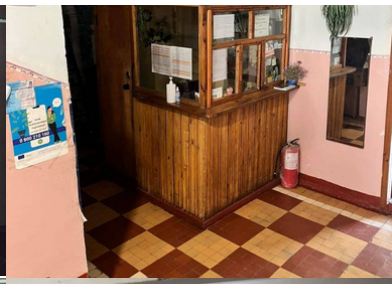
Kharkiv oblast, Dokuchaevske village, 12 Dokuchaeva Str, Dormitory of the State University of Biotechnology

The dormitory lacks accessibility features for people with special needs or limited mobility:

- No ramps, lifts, or threshold-free access between floors; the existing ramp leads only to the entrance.
- Pathways, doors, and bathrooms are not adapted for wheelchairs.
- No tactile paving, signage, or adapted toilets/showers available.
- The building structure is stable but shows cracks caused by explosions in 2022, requiring urgent wall repairs to prevent deterioration.
- The shelter (basement) exists but needs full renovation — including better insulation, toilet repairs, and accessibility improvements.
- Bathrooms and showers were partially renovated by NGOs but remain insufficient — particularly on lower floors.
- Plumbing is functional but outdated.
- Additional accessible bathrooms and showers are needed for residents with disabilities.

- Current Role: The dormitory serves as a vital shelter for displaced residents of Kharkiv.
- Key Needs: Strengthen safety infrastructure, improve accessibility, and ensure reliable utilities to enhance protection and living conditions.
- Priority Actions: Focus on electrical and heating system upgrades, shelter renovation, and universal access improvements to safeguard residents amid ongoing security risks.
