COLLECTIVE SITE(S) IN FRONTLINE OBLASTS: ACCESSIBILITY ASSESSMENT

Dormitory of the State University of Biotechnology, Dokuchaevske village, Kharkiv district

OCTOBER 2025

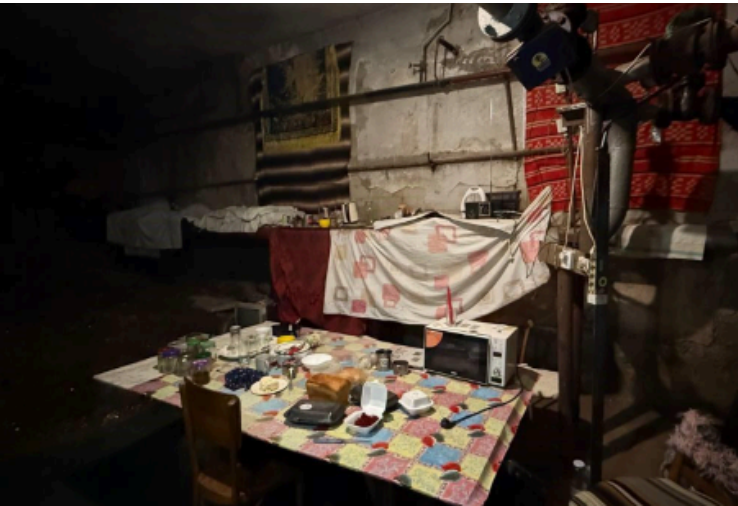
The site is officially recognised as a collective site by the authorities and accommodates 40 evacuees (including 5 persons with disabilities). In the last quarter, there have been explosions within 100–200 meters, creating potential safety risks. The site is used for multiple functions alongside hosting residents/IDPs. Some damage was observed but not affecting structural safety. There are several broken windows on one side of the building.

- The collective center is largely inaccessible for people with special needs/disabilities.
- Missing ramps, lifts, threshold-free doors, and non-slip flooring.
- Lack of Braille signage, tactile paving, or accessible toilets and kitchens.
- Shelter (bunker/safe space) is available but in very poor condition (structural and hygiene).
- The basement/shelter is fully insulated, but too small for all residents.
- Not accessible for residents with limited mobility.

- Shelter: Poor structural condition, no proper toilet, inadequate capacity - full structural
- Renovation; install proper toilets and ventilation; clean and disinfect; improve hygiene; ensure enough space for all residents.

- Windows & Structure: Broken windows, no anti-blast film - replace all damaged windows.
- Install anti-blast film; seal gaps to improve protection from blasts and weather.

- Accessibility (Mobility): No access for wheelchair users or people with reduced mobility - build ramps/lifts; widen entrances and corridors; install threshold-free doors; introduce non-slip flooring throughout.

- Sanitation: toilets and showers inaccessible, lacking grab bars - install accessible toilets and showers with grab bars and raised seats for people with reduced mobility

- Security & Protection: High risk due to recent nearby explosions - reinforce structural stability; establish emergency exits and signage; review evacuation plan.

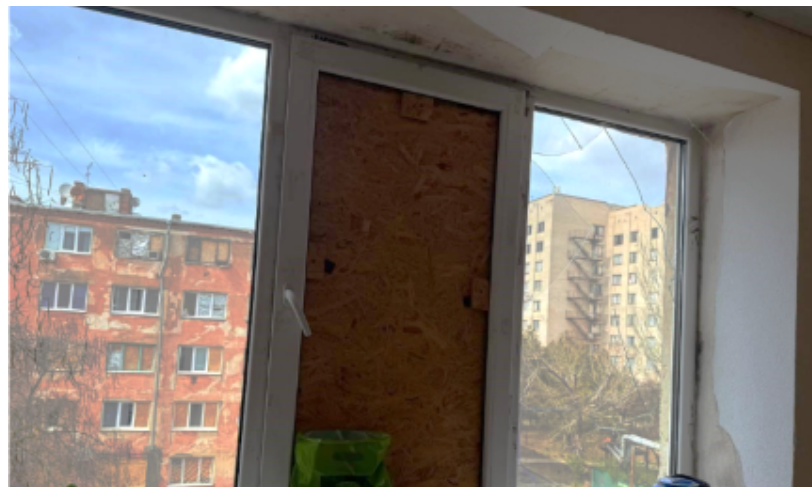
The site demonstrates significant progress in accessibility compared to many others, though some gaps remain. The building's structure is stable, with no major damage to the walls, roof, or foundations. However, anti-blast film is only partially installed on windows, requiring full coverage and periodic structural checks. Currently it accommodates 52 IDPs (no information on how many of these identify as having a disability).

- Ramps, lifts, wide entrances, threshold-free access, wide corridors.
- Accessible elevators and dining/kitchen areas.
- Easy-to-open doors, accessible tables, and manoeuvrable passageways.
- Braille and high-contrast informational signage.

- No non-slip flooring (stairs, corridors, kitchens).
- No benches with armrests for rest areas.
- No tactile paving for people with visual impairments.

- Safety / Security: Complete anti-blast window film installation; reinforce shelter ceiling and ventilation; inspect fire safety system.
- Accessibility & Mobility: Install non-slip flooring, tactile paving, accessible parking, and benches with armrests.

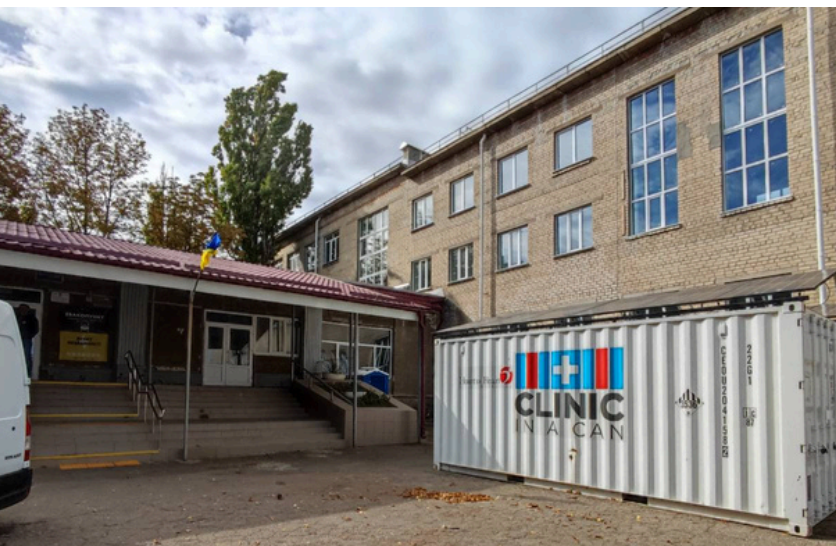
The building is in good structural condition, with no visible damage to walls, roof, or foundation. Constructed in the 1940s, the facility features thick brick walls and a slate roof with a stable wooden frame. No urgent repairs are required before further works begin.

The shelter in the basement is fully insulated and large enough for 150 people (no information on how many of these identify as having a disability). It is equipped with ventilation, alternative power, and water supply. Fire safety systems (detectors, extinguishers, alarms) are functional and properly installed.

- Shelter accessibility: The basement shelter includes two rooms for people with special needs / disabilities, and a mechanical chair system enables safe descent along stairs.
- Corridors and thresholds: Corridors are wide, and thresholds are low enough to permit passage for wheelchairs or reduced-mobility users.
- Toilets: equipped with grab bars, adequate space for manoeuvring, and raised-height toilets for easier transfers.
- Doorways: wide and threshold-free, allowing unimpeded access to key facilities.
- Visual accessibility: contrasting colour markings are used on stair edges and level changes for those with visual impairments.
- Tactile paving: Installed at the entrance to guide visually impaired users.

- Accessibility Improvements Needed: Enhance external mobility access with ramps, anti-slip surfaces, and accessible doors.
- Facilities Upgrades: Improve shower accessibility and provide inclusive furniture.
- Overall Assessment: The facility demonstrates high readiness for continued long-term use as a collective site, requiring only targeted accessibility upgrades.

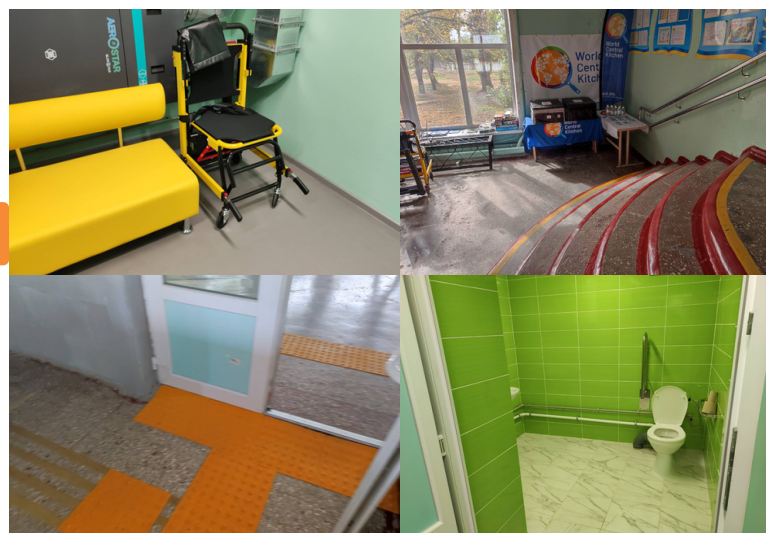
The collective site in Kharkiv operates within a nine-storey dormitory owned by the Kharkiv State Academy of Physical Culture. It accommodates 224 IDPs, including elderly people and children, across the 2nd to 5th floors (no information on how many of these identify as having a disability). The site is planned to continue operating after essential repairs. It is located in an area where security risks remain due to periodic attacks, though no recent strikes were recorded within 200m. The structure is generally stable, with minor non-critical damage to walls and surfaces.

- The external structure is generally stable, with minor non-critical damage to walls and surfaces.
- Windows lack anti-blast film, leaving residents vulnerable to shockwaves.
- A shelter exists in the building but is too small to accommodate all residents comfortably.
- The shelter is insulated and equipped with seating but lacks reinforced ventilation and emergency lighting.
- Entrance ramps are present, but internal mobility is limited — no accessible elevators, high thresholds, and no non-slip flooring.
- Bathrooms and showers for persons with disabilities are available but require improvement to ensure safety and usability.
- Kitchens are accessible and available on each floor but lack non-slip flooring and adjustable-height surfaces.

Needs priorities / Recommendations

- adding anti-reinforcing and ventilating the shelter and checking the fire safety system.
- non-slip flooring, upgrading toilets and showers with grab bars and level access, and adding ramps, clear signs, and accessible parking.

Overall, the site can continue to operate but needs these repairs to improve safety, resilience, and accessibility for all residents.

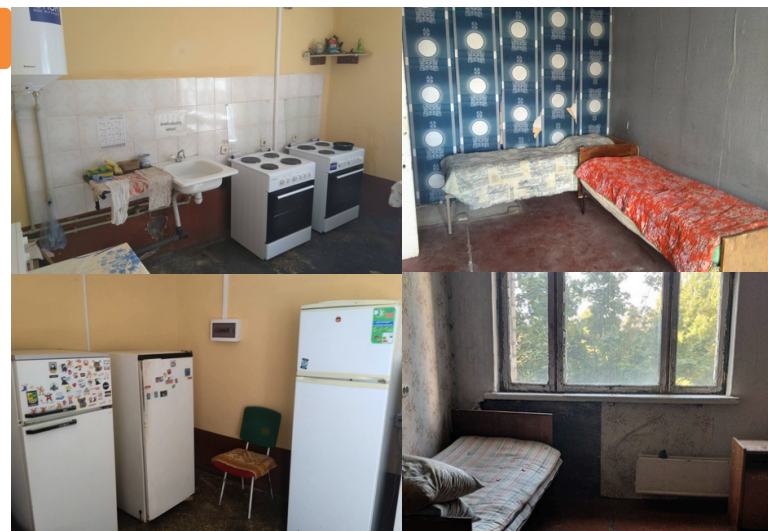
- Accessibility Gaps: The building lacks adequate features for people with disabilities or limited mobility.
- Limited Access: Ramps are available only at the entrance; internal doors and corridors are not adapted.
- Vertical Mobility: The elevator is non-functional, restricting access to upper floors.
- Provide emergency lighting, alarms, and first-aid kits throughout the premises.
- Repair and service the elevator to ensure mobility for residents with disabilities and older people.

Needs priorities / Recommendations

- Install internal ramps and non-slip flooring to enable safe movement throughout the building.
- Adapt WASH facilities with grab bars, raised toilets, and sufficient maneuvering space for wheelchair users.
- Ensure access to a functional and insulated shelter within or near the building.
- Add tactile paving and clear signage (including Braille) for people with visual impairments.
- Provide accessible entrances, benches with armrests, and parking spaces for persons with reduced mobility.

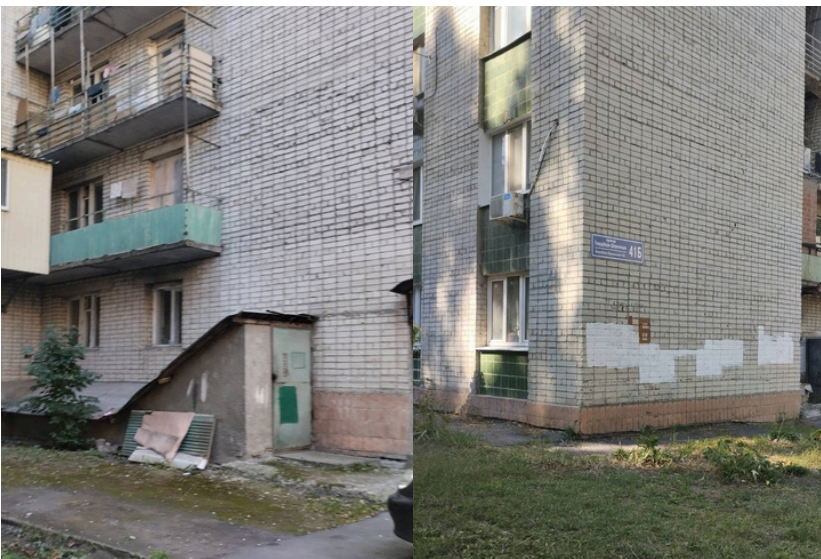
The dormitory, owned by the Kharkiv Regional Council Municipal Institution “Kharkiv Professional Higher College of Arts”, continues to serve as a collective site for 184 IDPs, most of whom are older adults (no information on how many of these identify as having a disability). While the building remains structurally stable, the assessment highlights several safety and accessibility gaps requiring prioritized action to ensure protection and inclusion of all residents.

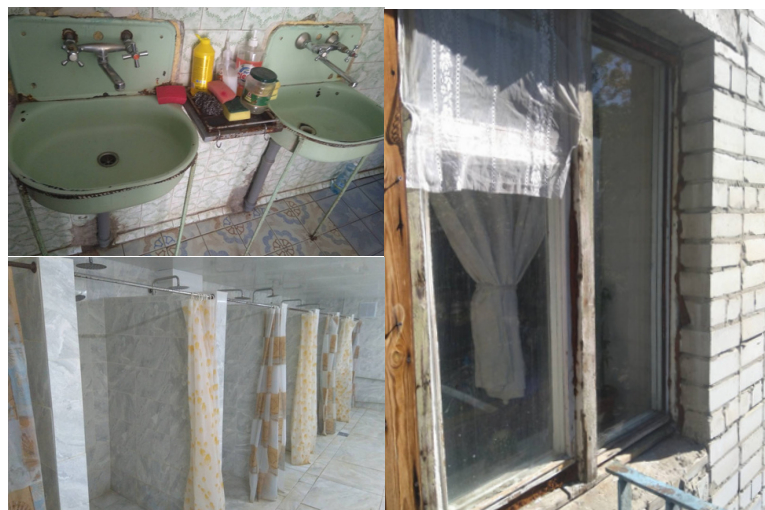
The collective site in Kharkiv is a nine-storey dormitory owned by the Kharkiv National University of Arts - is home to 70 IDPs (no information on how many of these identify as having a disability), mostly elderly people, sharing space with returning students. While the building is structurally sound and continues to operate, it faces serious safety, accessibility, and infrastructure challenges that require urgent attention to ensure secure and dignified living conditions.

- Electrical system enhancing: the wiring (dating back to 1974) is unsafe and unable to handle modern electrical loads, posing a major fire and safety risk.
- Shelter access: no on-site shelter exists; the nearest one is 100 meters away. A safe and accessible shelter solution within or adjacent to the building is urgently needed.
- The building has no ramps, lifts, or threshold-free access, making it completely inaccessible for wheelchair users or residents with limited mobility.
- Entrances, corridors, and WASH facilities must be adapted with ramps, non-slip flooring, wider doorways, grab bars, and accessible toilets and showers.
- No tactile paving, signage, or designated parking is available for people with disabilities, significantly limiting inclusivity.

Needs priorities / Recommendations

- Current Status: The Kharkiv dormitory remains operational but faces critical electrical hazards, no protective measures, and complete inaccessibility for people with disabilities.
- Priority Actions: Urgent safety and accessibility upgrades are needed to mitigate risks.
- Overall Impact: Enhancing safety and inclusivity will greatly improve living conditions and ensure the continued safe use of the site for IDPs and students.

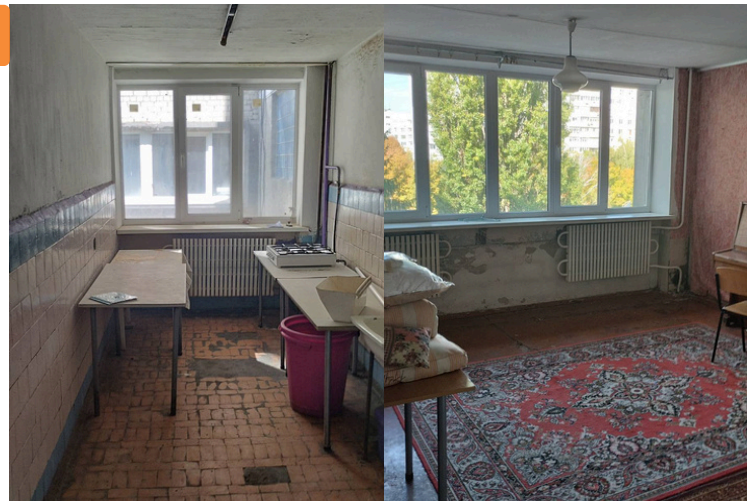
The dormitory, managed by the Kharkiv National University of Radio Electronics, currently houses 67 internally displaced persons (IDPs), most of whom are older adults (no information on the exact number of civilians identify as having a disability). It continues to function as a collective site and is expected to remain operational following essential repairs. The building's overall structural integrity is stable; however, several areas require targeted interventions to enhance safety, accessibility, and living conditions. Addressing these needs is critical to ensure that residents can live in a secure, inclusive, and dignified environment, especially under the current security risks in Kharkiv.

Needs priorities / Recommendations

- Install ramps, automatic doors, and low threshold entrances to allow wheelchair access.
- Repair and reactivate the elevator.
- Install non-slip flooring and tactile or high-contrast signage to support safe movement and orientation.
- Create designated parking for people with disabilities and rest benches with armrests outside the building.

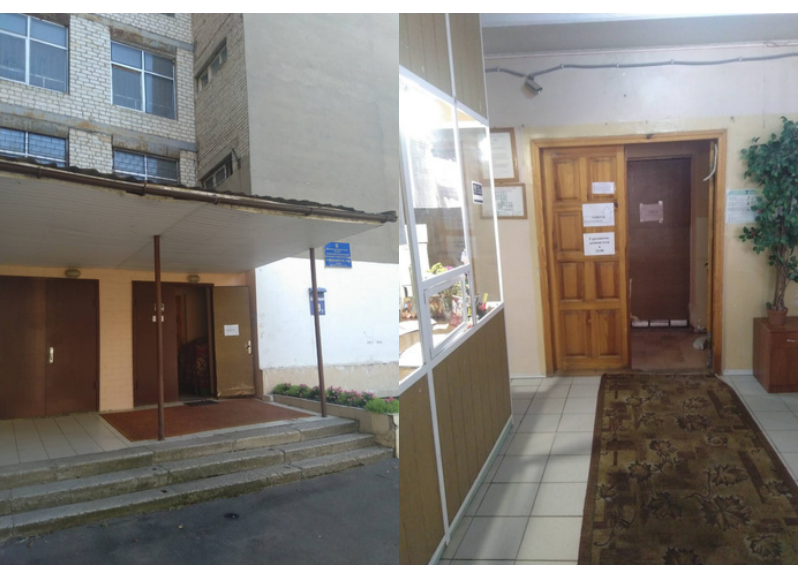
- No on-site shelter exists; residents rely on a small room unsuitable for full occupancy. A nearby metro station (300 m away) serves as the only shelter, highlighting the need for a safer, accessible space within or adjacent to the building.
- Fire safety is adequate, with extinguishers on each floor, but regular checks and evacuation signage should be maintained.
- The site is not accessible for persons with disabilities or reduced mobility.

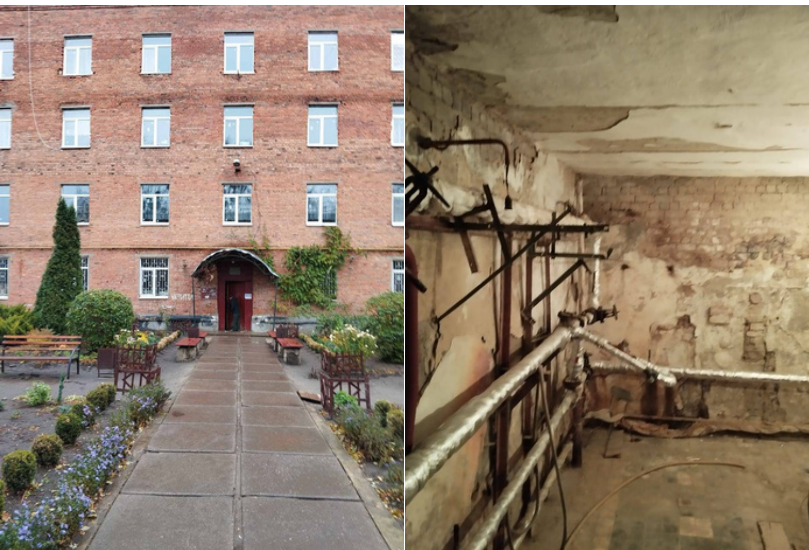
The dormitory of the State University of Biotechnology in Kharkiv accommodates 167 residents who are mainly IDPs, including elderly residents, persons with disabilities, and families from conflict-affected areas (no information on the exact number of civilians identify as having a disability). Despite partial renovations supported by humanitarian partners, the building requires further repairs to improve safety, accessibility, and essential services. Given Kharkiv's exposure to regular shelling and drone strikes, maintaining and strengthening this facility is critical to ensuring residents' safety and resilience.

- No ramps, lifts, or threshold-free access between floors; the existing ramp leads only to the entrance.
- Pathways, doors, and bathrooms are not adapted for wheelchairs.
- No tactile paving, signage, or adapted toilets/showers available.
- The building structure is stable but shows cracks caused by explosions in 2022, requiring urgent wall repairs to prevent deterioration.
- The shelter (basement) exists but needs full renovation — including better insulation, toilet repairs, and accessibility improvements.
- Bathrooms and showers were partially renovated by NGOs but remain insufficient — particularly on lower floors.
- Plumbing is functional but outdated.
- Additional accessible bathrooms and showers are needed for residents with disabilities.

- Current Role: The dormitory serves as a vital shelter for displaced residents of Kharkiv.
- Key Needs: Strengthen safety infrastructure, improve accessibility, and ensure reliable utilities to enhance protection and living conditions.
- Priority Actions: Focus on electrical and heating system upgrades, shelter renovation, and universal access improvements to safeguard residents amid ongoing security risks.

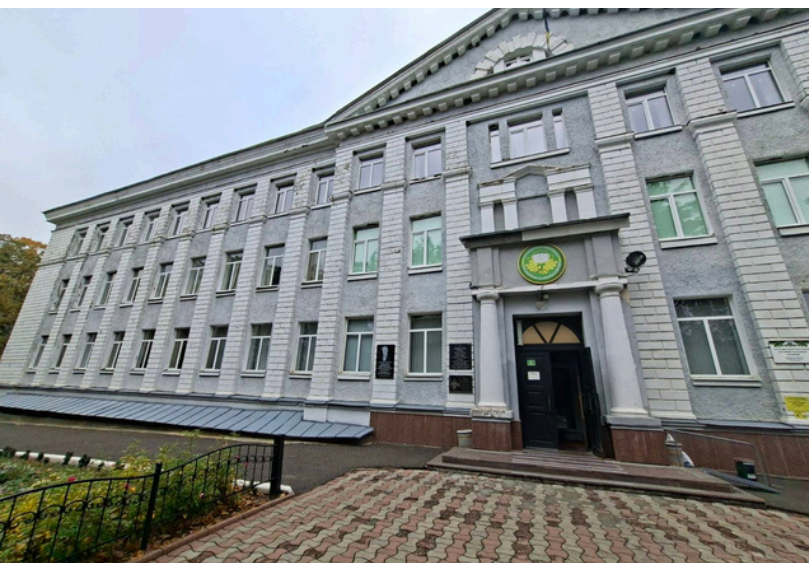
The dormitory of the Forest College continues to function as a collective site accommodating internally displaced persons (IDPs), including elderly individuals and persons with disabilities. The site comprises two buildings — a three-floor dormitory and a five-floor building. It is partially in use after missiles heavy attack during the summer 2022, which caused several damages to the roof and the walls on one side, require urgent attention. Some windows are broken, and none are covered with anti-blast film, increasing vulnerability during air attacks. The Collective sites in Kochetok accommodates 53 people, including 15 IDPs with disabilities.

- The site partially meets accessibility standards but needs major upgrades.
- Ramps are missing at key access points, including the main building and shelter.
- Signage is limited, lacking tactile and directional elements.
- WASH and living areas require grab bars, wider doors, and level showers.
- The absence of elevators restricts movement for people with mobility impairments.
- Public transport, healthcare access, and NGO support (Caritas, Proliska, SOS East, IOM, Angels of Salvation) remain strong.

- Install ramps at main entrances and shelter access points.
- Replace uneven tiles with non-slip flooring.
- Add tactile paving, high-contrast markings, and clear signage.
- Upgrade WASH facilities with grab bars, wider doors, and level showers.
- Install elevators or lifts for access between floors.
- Ensure smooth, barrier-free pathways and door thresholds.
- Designate accessible rooms and toilets on each floor.
- Apply inclusive design standards in all repairs and upgrades.

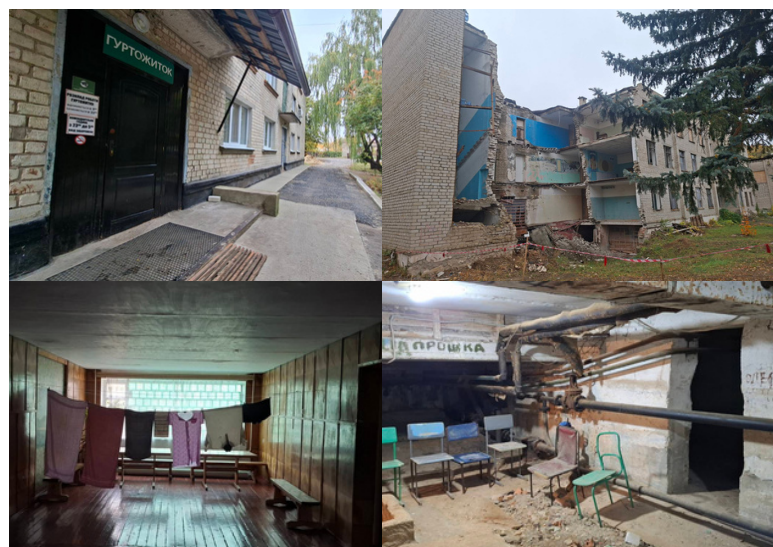
While the overall structural condition is stable, multiple critical repairs are required to ensure the site's safety, accessibility, and resilience, especially considering the absence of a nearby shelter and outdated infrastructure.

Needs priorities / Recommendations

- Urgent basement and balcony repairs, electrical system upgrades, and accessibility improvements are required to address safety and inclusivity gaps.
- The absence of a secure shelter, outdated infrastructure, and limited accessibility pose serious risks to residents.
- Targeted repairs and accessibility upgrades will significantly enhance safety, living conditions, and compliance with minimum protection standards.
- Despite these challenges, residents remain organized and cooperative, supported by NGOs such as Rokada, Dignitas Ukraine, and Spilna Sprava.

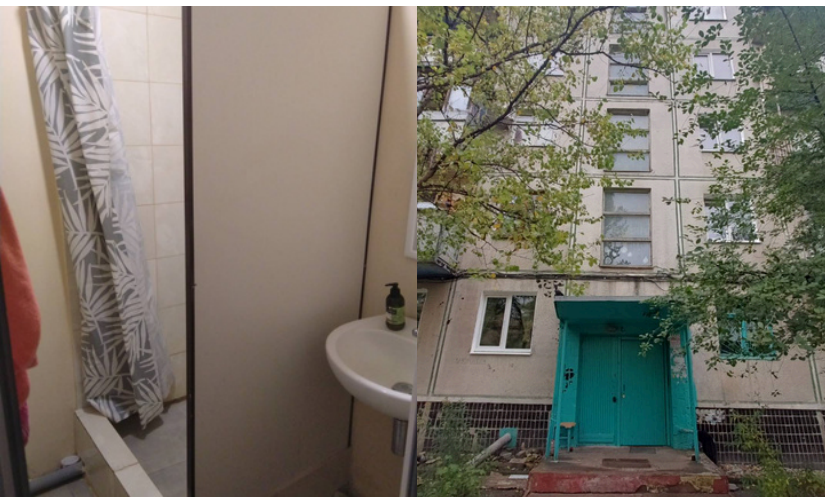
The assessed facility is part of a four-entrance residential building, with the collective center occupying Entrance No. 2 of the dormitory. It accommodates 44 IDPs, including elderly individuals and 1 wheelchair user. The dormitory remains operational and is planned to continue functioning after repairs.

- There is no on-site shelter - only a technical basement - leaving residents without a safe refuge during shelling. The nearest available shelter is 400 meters away at the nearby school, or at subway station.
- The site does not meet accessibility standards for persons with special needs or reduced mobility.
- The entrance, stairs, and common areas are not equipped with ramps or lifts, and door thresholds are high. Non-slip flooring is absent, and tactile signage or paving is unavailable.
- Corridors and kitchens are relatively wide, allowing partial wheelchair access, but toilets and showers are not adapted. A wheelchair user on the first floor must rely on a dry bio-toilet due to lack of accessible sanitation.

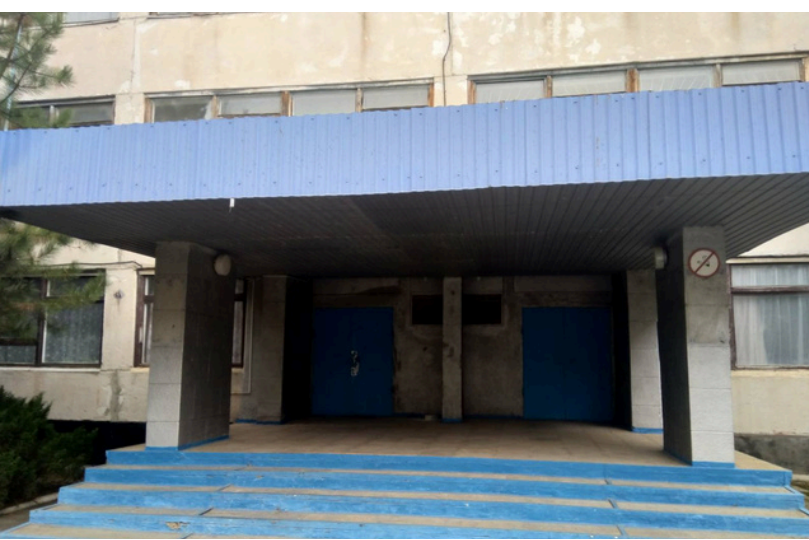
The site, part of the Lozivsky Professional Higher College of Arts is currently functioning as a collective site for IDPs and is planned to continue operating after necessary repairs. However, the overall condition and infrastructure of the facility require significant improvement before it can meet basic safety, accessibility, and comfort standards.

At the time of assessment, no structural damage or ongoing safety threats were observed, but the facility lacks essential functional systems, accessibility features, and emergency preparedness measures. Dormitory hosts 35 IDPs, including 3 persons with disabilities.

- The facility lacks infrastructure for persons with disabilities or limited mobility.
- It requires the installation of ramps, lifts, and adapted toilets.
- Internal and external movement for wheelchair users is highly restricted.
- The entrance should be adapted with ramps for better accessibility.
- Although kitchen doorways are sufficiently wide, the overall environment remains inaccessible.

- Restore essential systems, including heating, plumbing, and electricity.
- Establish basic fire and shelter safety measures.
- Ensure full accessibility for all residents before continued occupancy.
- Equip entrances, corridors, and stairs for wheelchair users by adding ramps or lifts.
- Install non-slip flooring, handrails, tactile paving, and clear directional signage.
- Upgrade WASH facilities to meet accessibility standards by adding grab bars, raised toilets, and level shower trays.
- Maintain the structurally sound walls, roof, and foundation to preserve stability.
